PUBLIC ROADS

APRIL-MAY-JUNE 1946

LONGITUDINAL CRACKING IN CONCRETE PAVEMENTS

A REPORT ON A STUDY OF CRACKING IN KENTUCKY, INDIANA, AND ILLINOIS

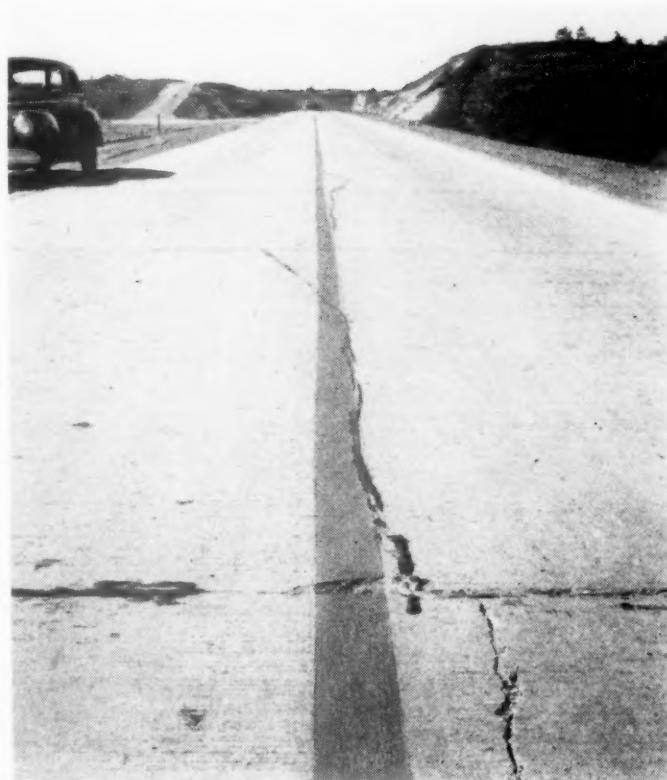
FIGURE 1.—LONGITUDINAL CRACK IN SECTION OF PAVEMENT WHERE THE CENTER JOINT HAS NOT CRACKED.

In the 1943 survey all but one or two of the longitudinal cracks were found in panels where the dummy center joint had not fractured and therefore was not functioning as a longitudinal joint. Figure 1 shows a typical example of this condition.

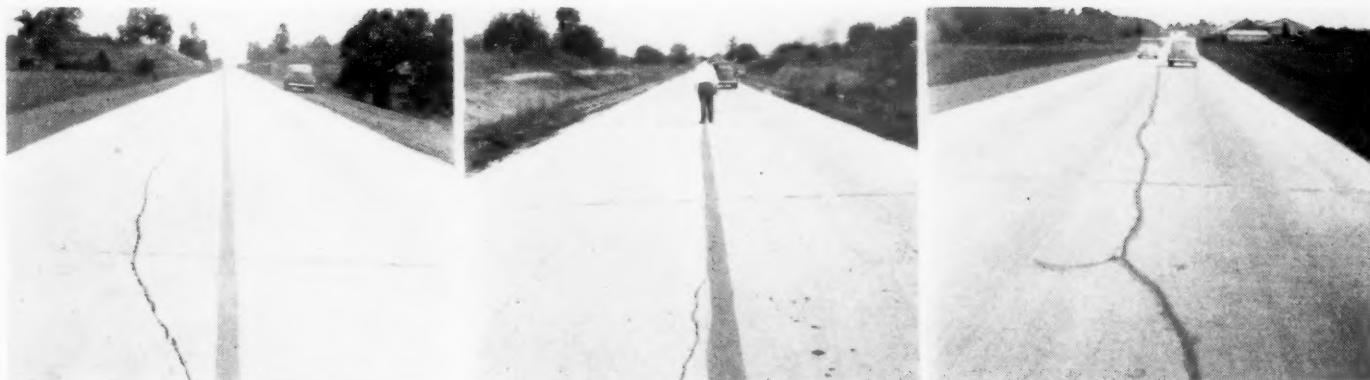
Many of the cracks had opened up badly because of the absence of reinforcement in the pavement and of tie bars in the longitudinal joint. Figure 3 shows several typical examples of cracking in the Kentucky pavements laid in 1942.

FIGURE 3.—TYPICAL LONGITUDINAL CRACKS IN THE 1942 KENTUCKY PAVEMENTS.

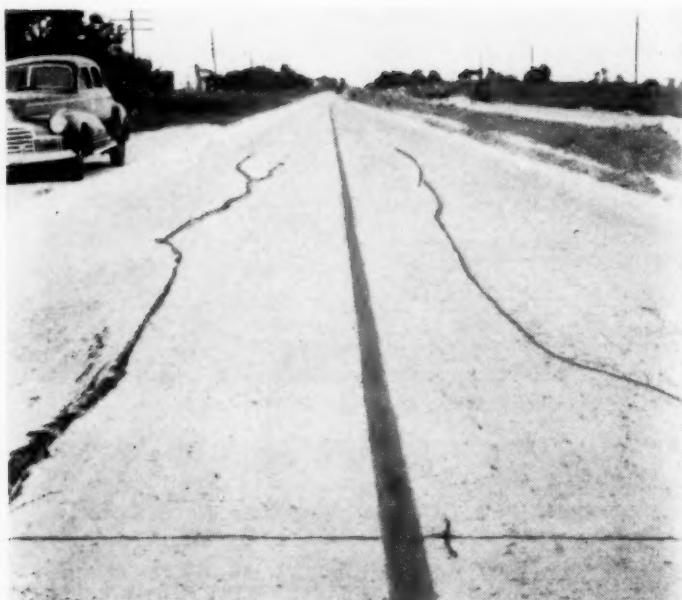
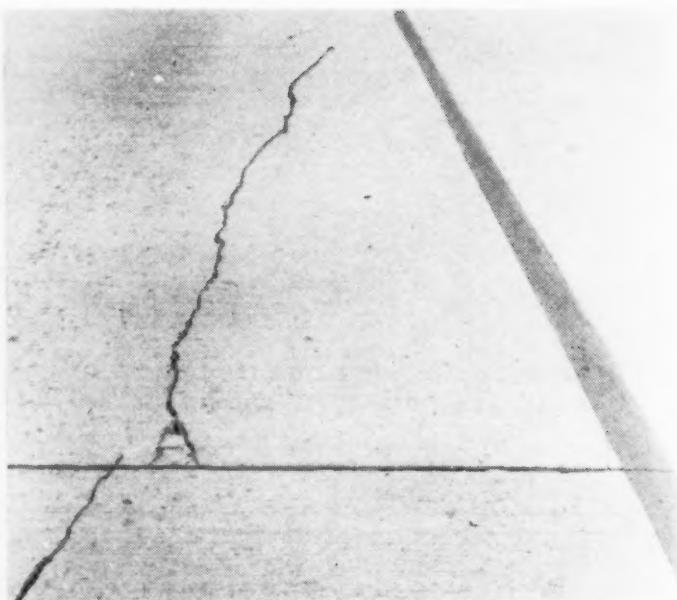
FIGURE 5.—TYPICAL LONGITUDINAL CRACKS OBSERVED IN 1943 IN INDIANA PAVEMENT SN-FA 13-B (2).

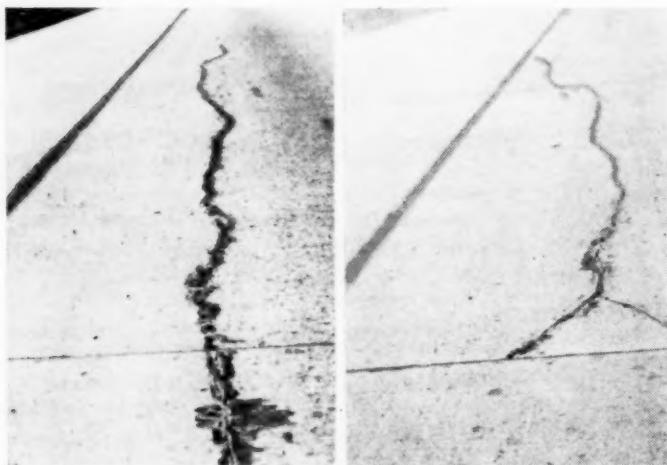
FIGURE 6.—TYPICAL LONGITUDINAL CRACKS OBSERVED IN 1944 IN INDIANA PAVEMENT SN-FA 13-B (2).

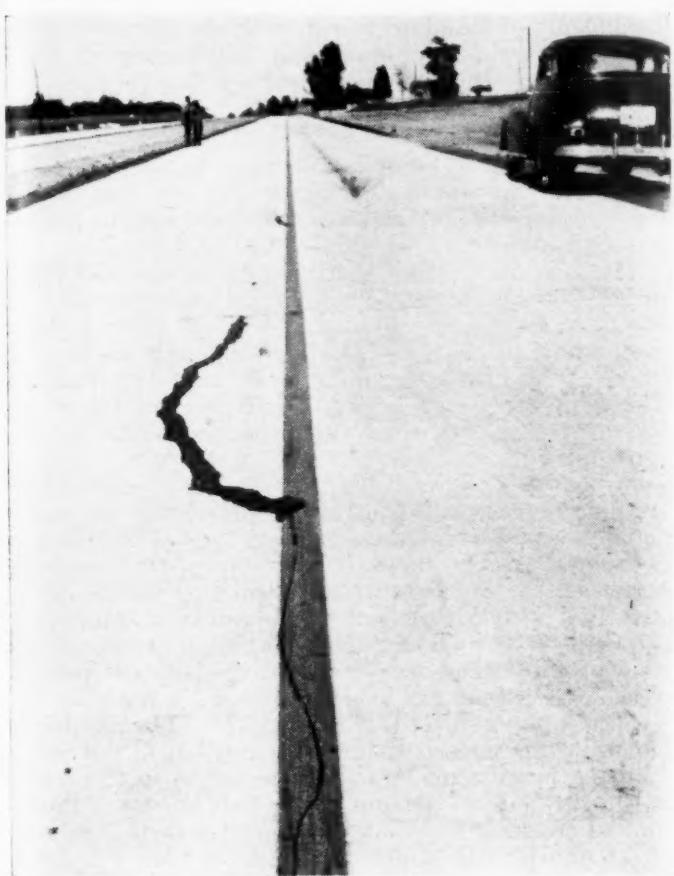
Indiana pavement SN-FA 74-A(2) A(3) B(5).—The longitudinal cracking in this pavement is not serious. In the 1943 survey it was found that 3 percent of the panels contained some form of longitudinal cracking while at the time of the 1944 survey the value had increased to 4 percent. More than 90 percent of the cracks were part length ranging from 2 to 8 feet in length and, as a rule, they were not more than 6 to 12 inches from the center joint.

FIGURE 7.—TYPICAL LONGITUDINAL CRACKS IN INDIANA PAVEMENT SN-FA 74 A (2), A (3), B (5).

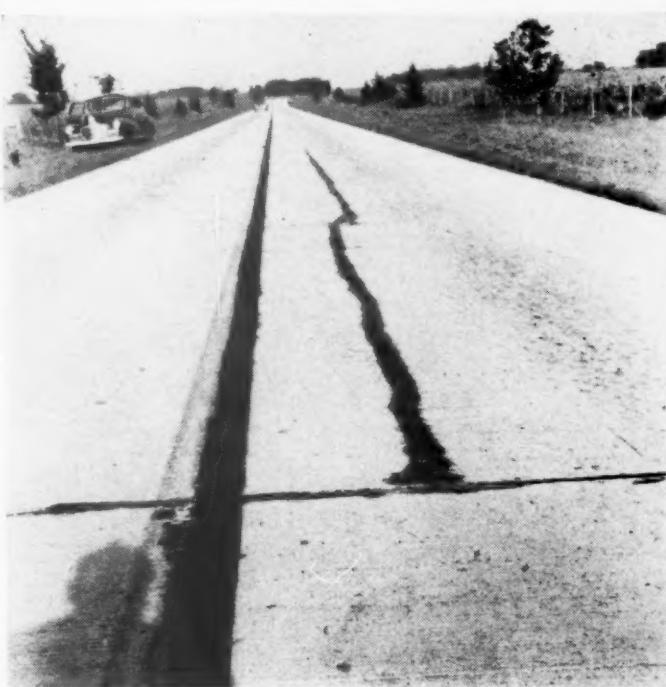
FIGURE 8.—LONGITUDINAL CRACKING IN THE OLDER REINFORCED PAVEMENTS WITH DUMMY CENTER JOINT LAID IN INDIANA IN 1937 (74-E).

It was found that a small number of longitudinal cracks have formed in these pavements. The majority of these break from the center joint at some intermediate point and continue the remaining length of the panel and, as found in the 1942 pavements, the center joint had not fractured in the panels or parts of panels where the longitudinal cracking developed. Figure 8 shows typical longitudinal cracks found in these pavements.
